明函

关于市场监管总局 2021-4-14 发布的《市场监管总局办公厅关于开展电梯鼓式制动器安全隐患专项排查治理的通知（市监特设函〔2021〕564号）》中所述的“2”

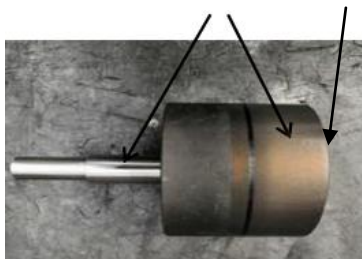
2

3
4

5
6
7

0.05mm

制动器内部维护完毕后，请按拆序逆序装配。

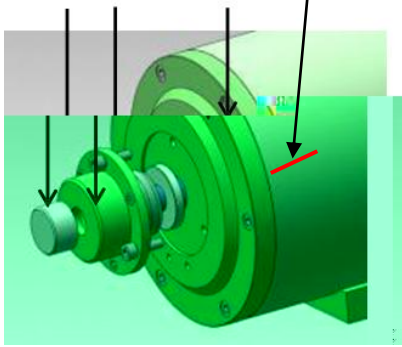
- 2
- 3
- 4

- 5
- 6
- 7
- 8

0.05mm

制动器内部维护完毕后，请按拆序逆序装配。

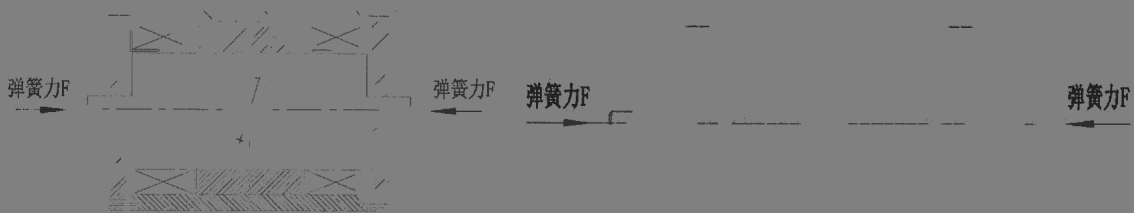
(SHB 型)

(WL 型)

1.2、SHB 型、WL 型制动器的手动松闸复位后，定位装置自动定位，在电磁力作用下不会产生摆动，不会使制动器卡阻。

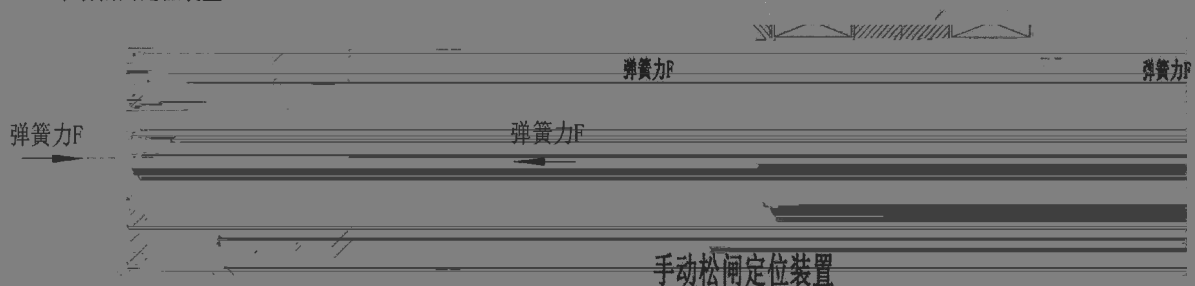
手动松闸定位装置

(SHB 型)

(WL 型)
